PRELIMINARY ASSESSMENT

Durango Lead Smelter Durango, Colorado

CERCLIS ID #CO0001399633

EPA Contract No. 68-W5-0031 TDD No. 9602-0001

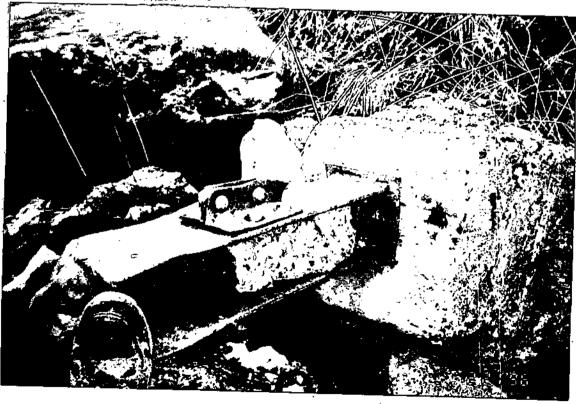
#### PHOTO 2

Photo taken of foundation material (with metal beam) found along the west bank of the Animas River.

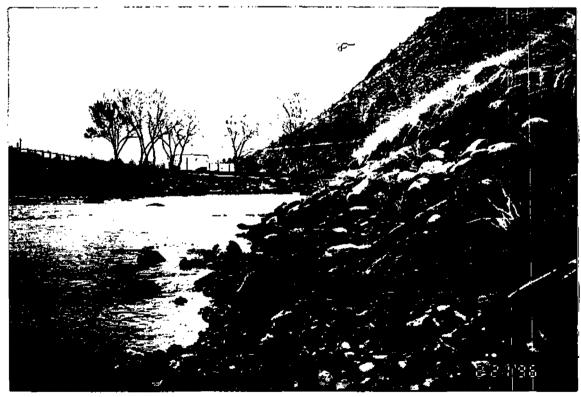
#### **PHOTO 4**

Slag was observed to be sloughing into the Animas River from its location along the west bank.

View to the south of the west bank of the Animas River. Note slag material sloughing into the river.
